# Ridgid R86034 Motor Replacement

Replace a broken motor to return your RIDGID X4 18V Lithium-Ion Impact Driver to working condition.

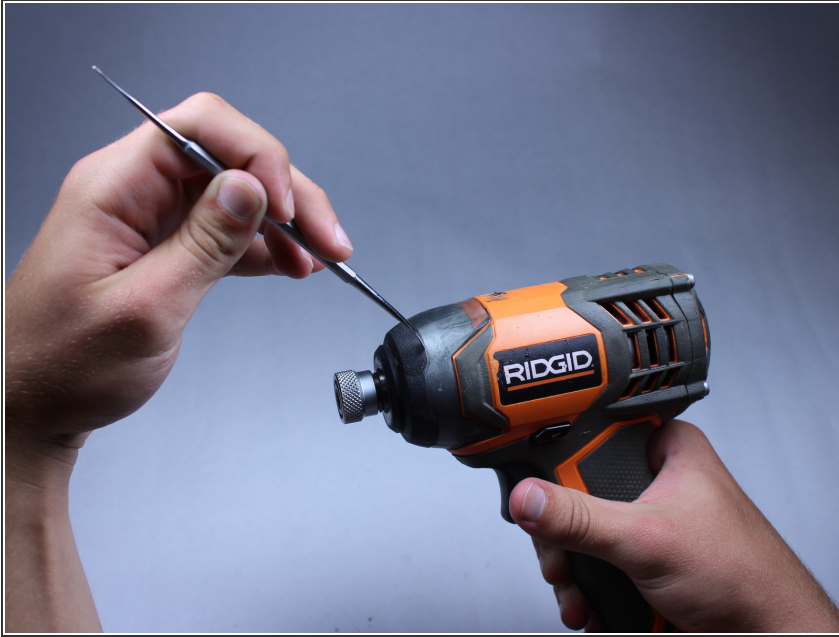
## Step 1 — Housing

- Peel the black rubber cover off of the casing using the flat metal spudger. The rubber cover is securely attached to the housing so some force is necessary.
- ☑ When putting the rubber cover back the driver remember that its orientation is important. Rotate the casing until it fits onto the housing with no gaps between it and the clear cover.

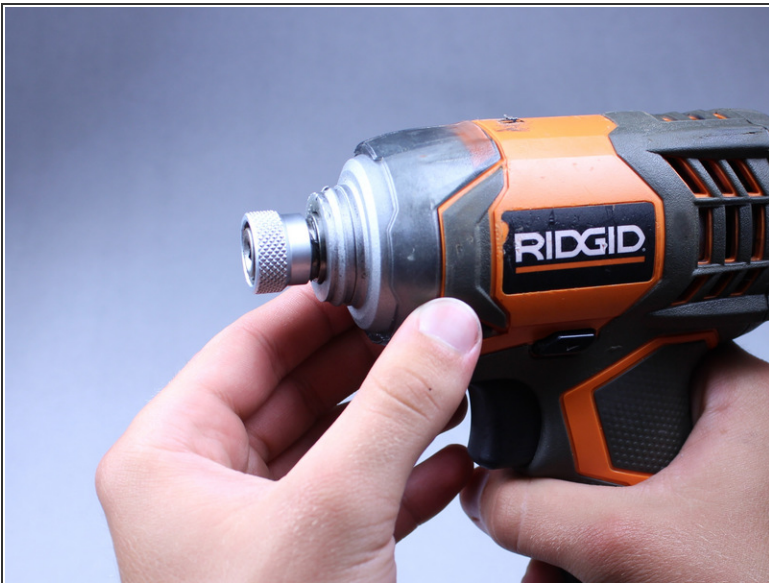
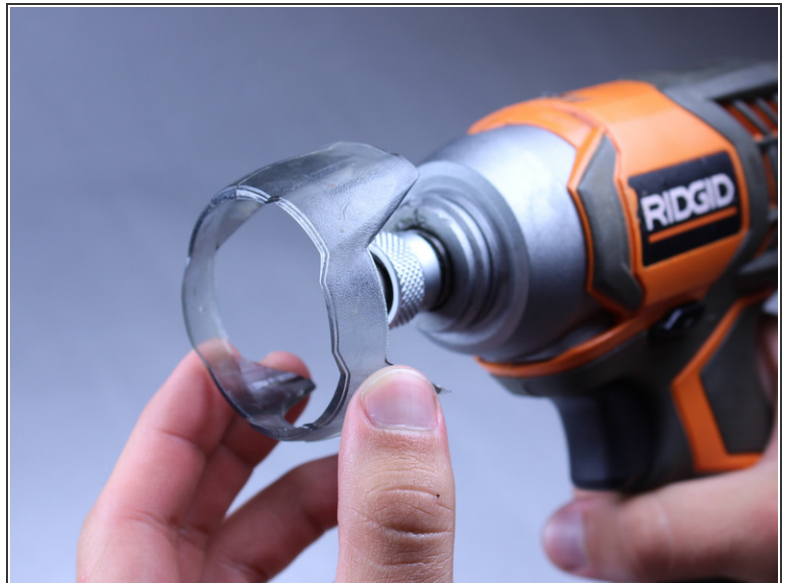
## Step 2

- Remove plastic cover with your hands. The plastic cover should be much easier to remove than the rubber cover. There is no need to force it off.

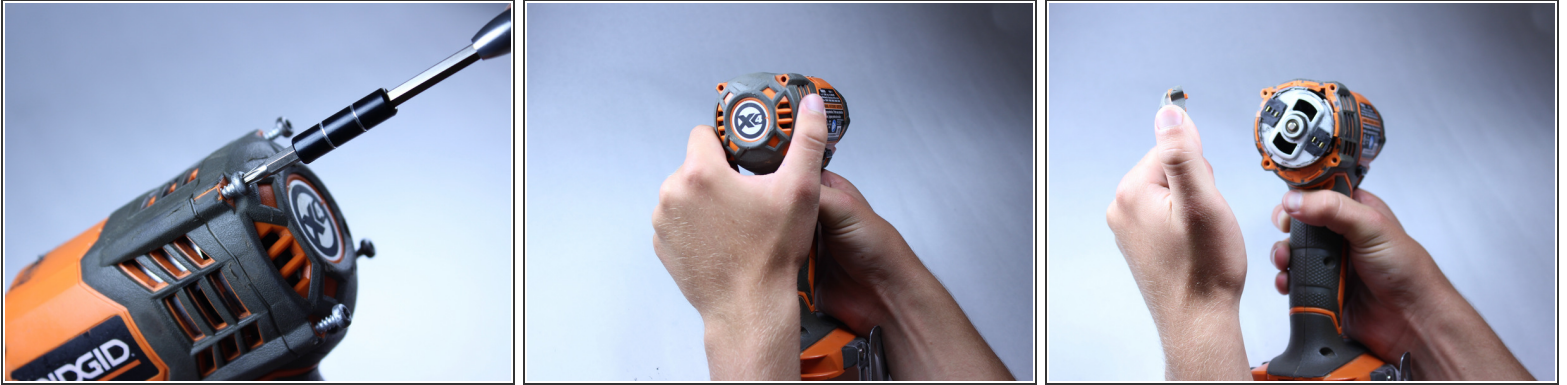
## Step 3

- Unscrew the four 16 mm long screws from back panel with a T10 Torx Screwdriver.
- Use a firm grip to peel the the back panel off. It is sealed tight and requires a good amount of force to remove.

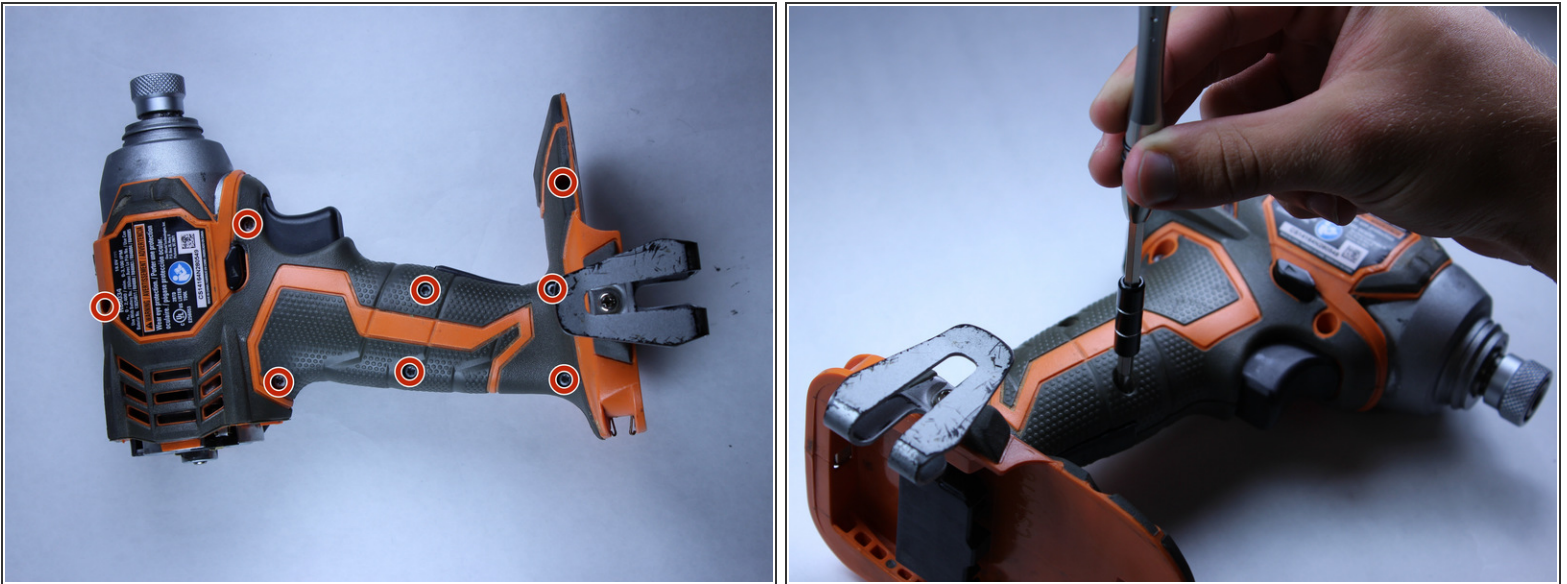
## Step 4

- Unscrew the eight 15 mm T10 Torx screws from the housing
- ⓘ The screw hole located nearest the battery port is deep and small. Most screwdrivers with replaceable bits will **not** fit into the hole. Instead use a conventional screwdriver that fits.

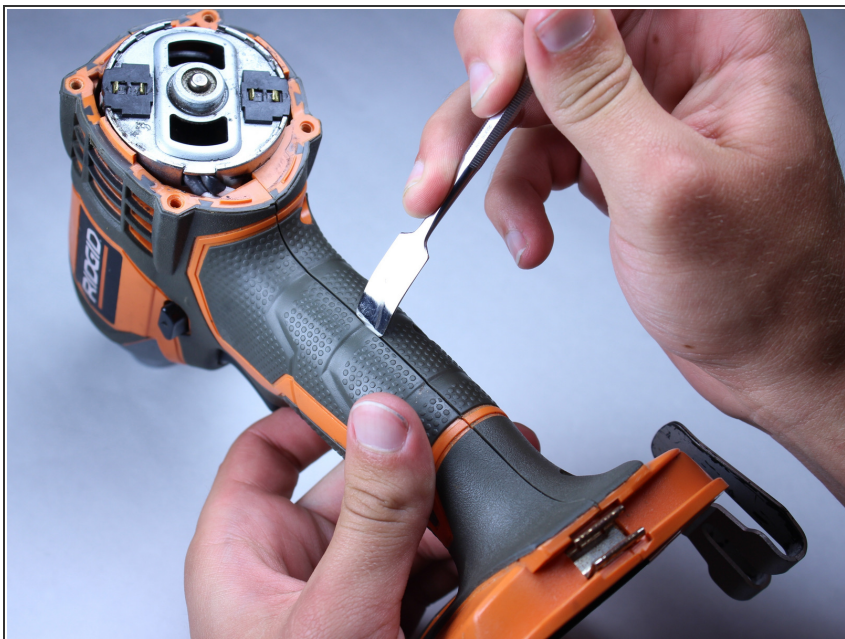
## Step 5

Place the driver flat on a table before completely separating the two halves of the housing so components don't fall out during opening.

- Pry apart the two halves of the housing at the back side of the driver using the metal spudger .

The housing is easier to remove if you pry from multiple sides.

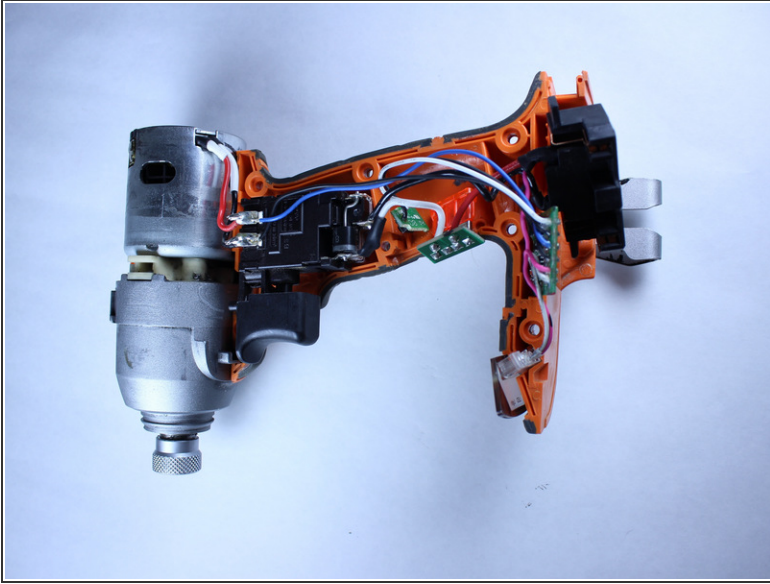
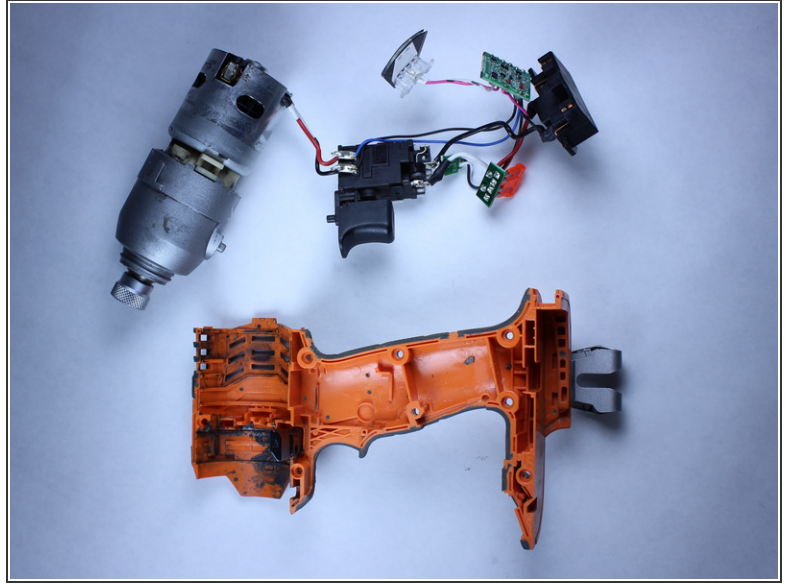
## Step 6

Do not remove the direction switch. It isn't necessary.

- Pull out **all** electrical components from housing by hand. First, lift out the motor. Next, follow the wires, lifting out components until all components are outside of the housing.
-

With two exceptions all of the components should come out of their respective slots with ease and require little force to lift out. The circuit board located nearest the battery pack and the LED light will be hard to pull out.
-

When reassembling remember to precisely place all components in their correct slots with their correct orientations.

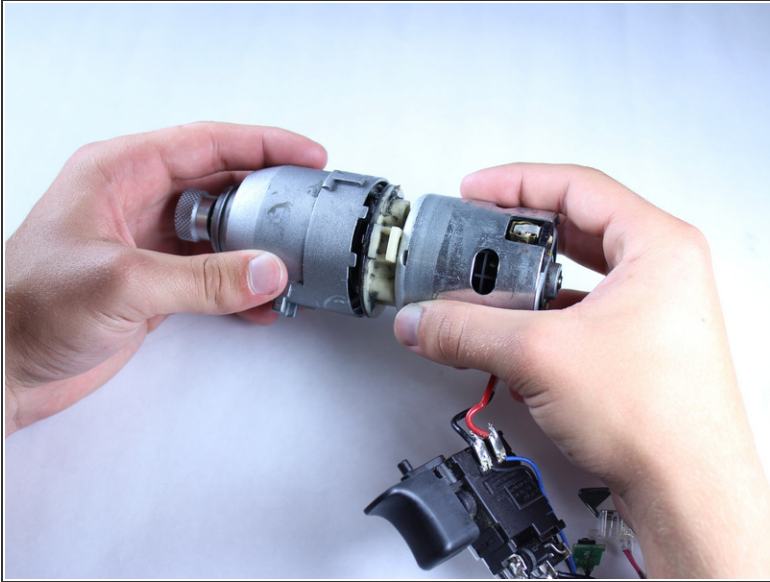
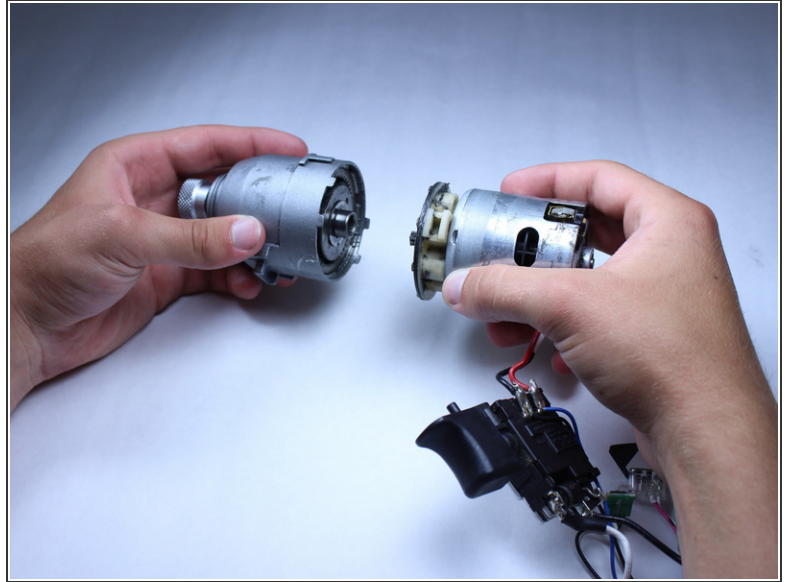
## Step 7 — Motor

Do not invert gear assembly! Keep gear assembly oriented so that the chuck is lower and the place the motor was attached is higher or else gears could fall out.

- Twist off and separate the gear assembly from the motor assembly.
-

Some force will be required to twist off the gear assembly.
-

When putting the motor back onto the gear assembly, make sure that the tabs on the edge of the gear assembly are oriented to fit the tabs found on the edges of the motor.

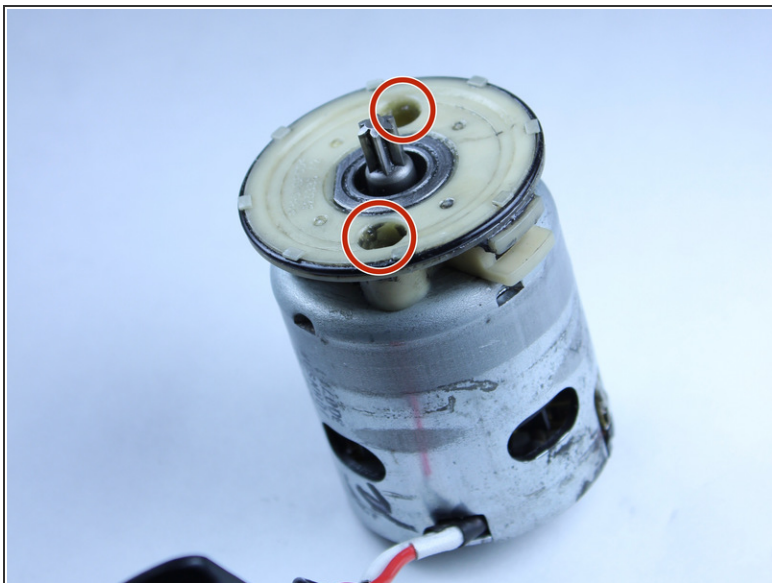
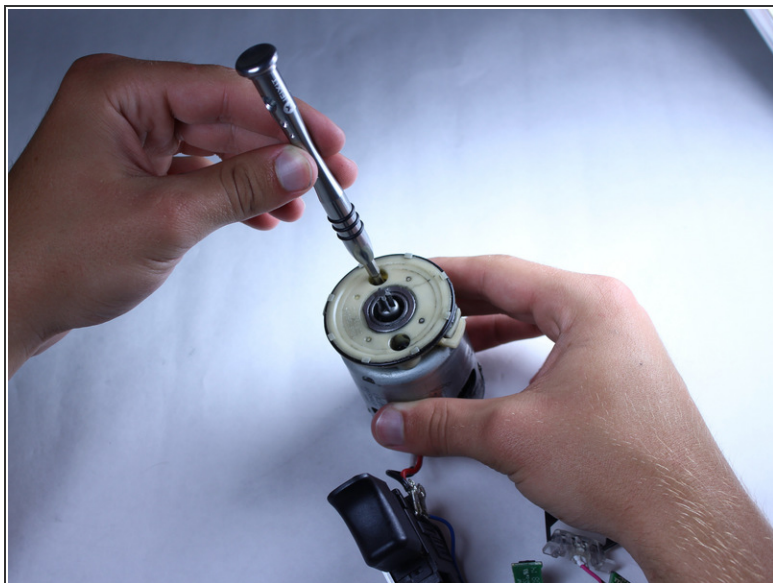
## Step 8

- Remove the two 14 mm long PH1 screws that connect the plastic object to the motor assembly.

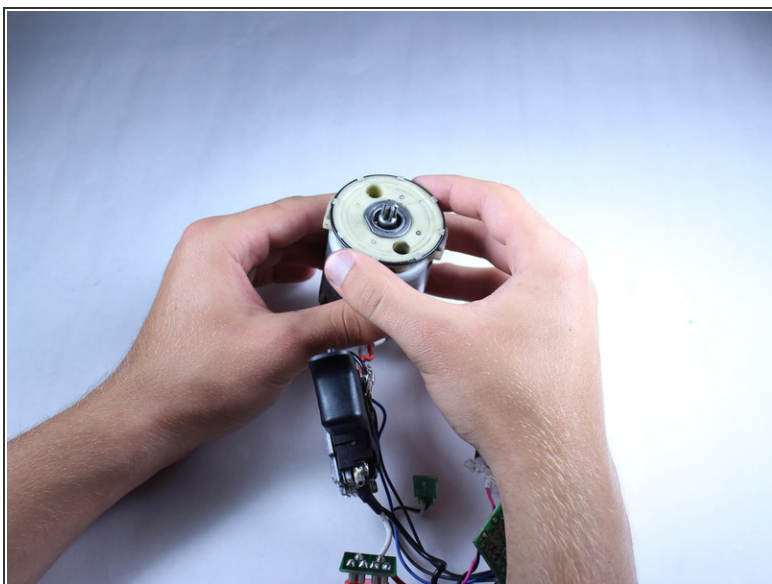
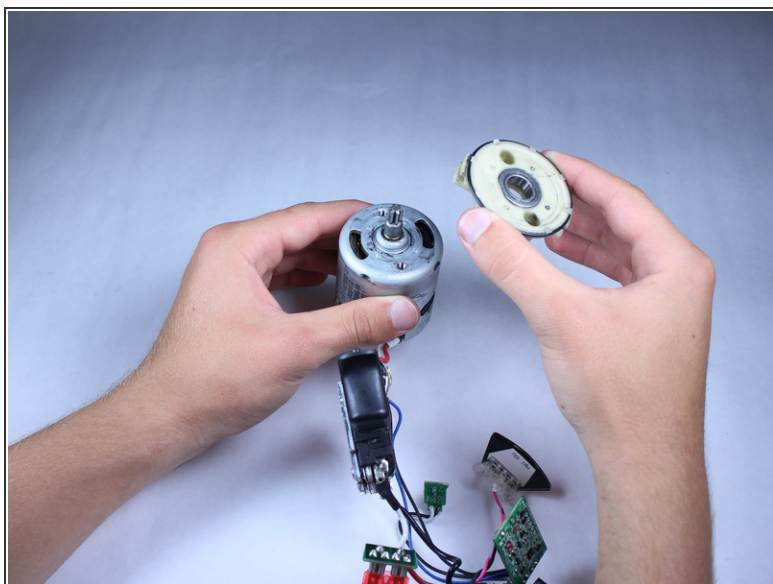
## Step 9

- Remove the plastic object from the motor assembly.

It should not require that much force to remove the plastic object.

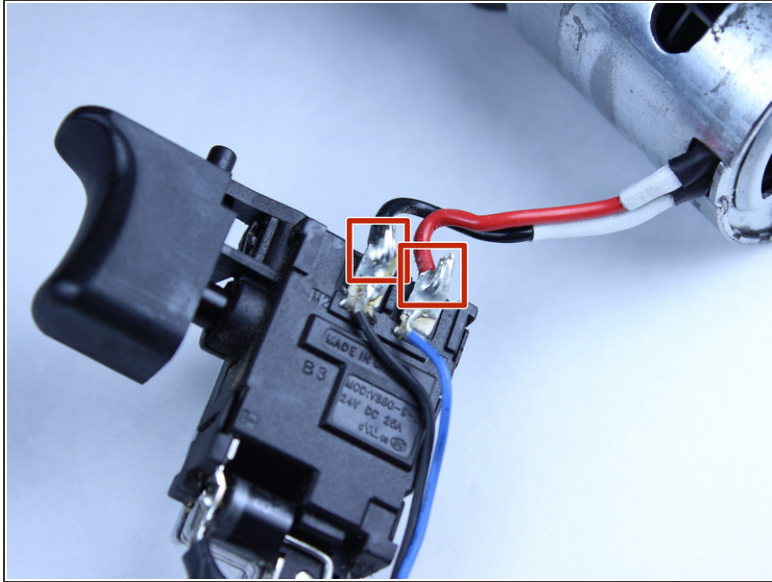
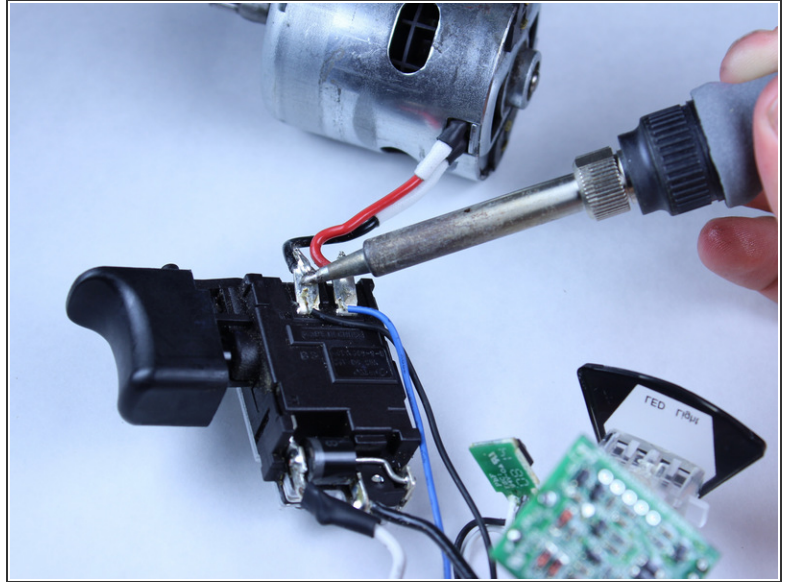
## Step 10

- Desolder and remove the red and black wires connecting the trigger assembly and the motor.
- ✦ Take note of the orientation of the wires for when they need to be resoldered.
- ⓘ You should only desolder the top-left black wire and the top-right red wire, not the bottom-left black wire or the blue wire.
